LAKE SHERWOOD DAM
ST. LOUIS COUNTY, MISSOURI
MO. 11017

PHASE I INSPECTION REPORT NATIONAL DAM SAFETY PROGRAM

Name of Dam: Lake Sherwood Dam, Missouri Inv. No. 11017
State Located: Missouri
County Located: St. Louis
Stream: Headwaters of the River des Peres
Date of Inspection: June 11, 1979

PHASE I INSPECTION REPORT
NATIONAL DAM SAFETY PROGRAM

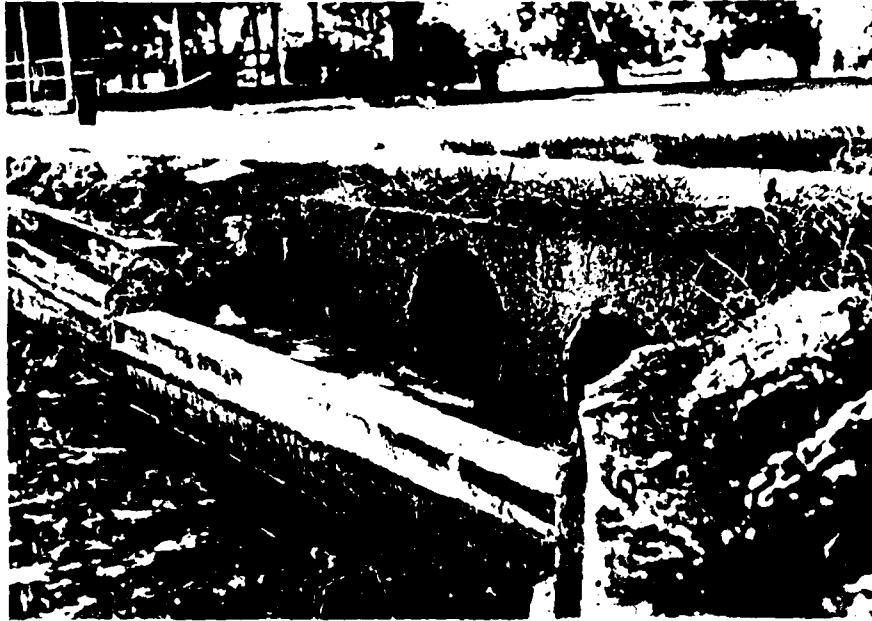
Photo 7

- Photo 7. - View of the intake to the right abutment spillway.
- Photo 8. - View of the outlet of the right abutment spillway.
- Photo 9. - View of the concrete spillway discharge channel on the right abutment. Note the erosion on the left side of channel.
